**DEPARTMENT OF TRANSPORTATION****DIVISION OF ENGINEERING SERVICES**

Contract #: 04-0120F4Cty: SF/ALA Rte: 80 PM: 13.2/13.9File #: 69.28**WELDING INSPECTION REPORT****Resident Engineer:** Pursell, Gary**Address:** 333 Burma Road**City:** Oakland, CA 94607**Report No:** WIR-000520**Date Inspected:** 23-Sep-2007**Project Name:** SAS Superstructure**OSM Arrival Time:** 1400**Prime Contractor:** American Bridge/Fluor Enterprises, a JV**OSM Departure Time:** 2330**Contractor:** Zhenhua Port Machinery Company, Ltd (ZPMC), Changxing Island **Location:** Shanghai, China**CWI Name:** Lu Jian Ping, Xu Le Feng**CWI Present:** Yes No**Inspected CWI report:** Yes No N/A**Rod Oven in Use:** Yes No N/A**Electrode to specification:** Yes No N/A**Weld Procedures Followed:** Yes No N/A**Qualified Welders:** Yes No N/A**Verified Joint Fit-up:** Yes No N/A**Approved Drawings:** Yes No N/A**Approved WPS:** Yes No N/A**Delayed / Cancelled:** Yes No N/A**Bridge No:** 34-0006**Component:** 89 and 144 meter mock-up**Summary of Items Observed:**

**114 Meter Mockup-skin plate B (UT-repair):**

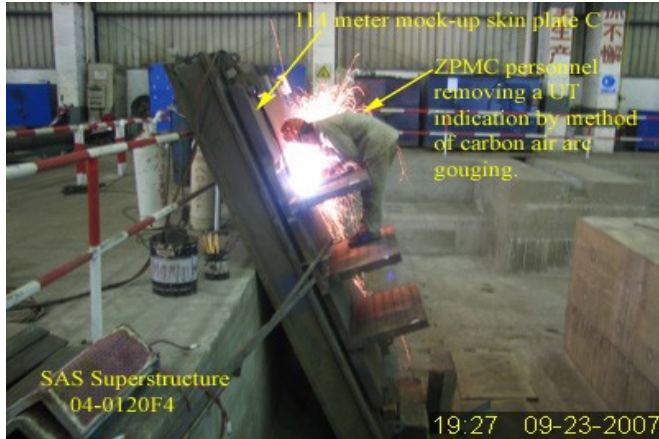
QA Inspector Brannon randomly observed ZPMC personnel at skin plate C removing an ultrasonic testing (UT) indication found by ZPMC by method of carbon air gouging on weld joint #13 sides A and B sub assembly MA112.

The following digital photograph illustrates ZPMC personnel in the process of removing a ultrasonic testing (UT) indication by method of carbon air gouging.
